Report Number: 109944

Re: Non-compliance Advisory Letter, Hazardous Waste Regulation HW109944, 4501 Farstad Way, Skookumchuck BC, Hazardous Waste

On November 20, 2018, Ministry of Environment and Climate Change Strategy, Environmental Protection Division staff conducted an inspection of your facility, SKOOKUMCHUCK PULP INC. located at 4501 Farstad Way, Skookumchuck BC with authorization number HW109944 under the *Environmental Management Act*.

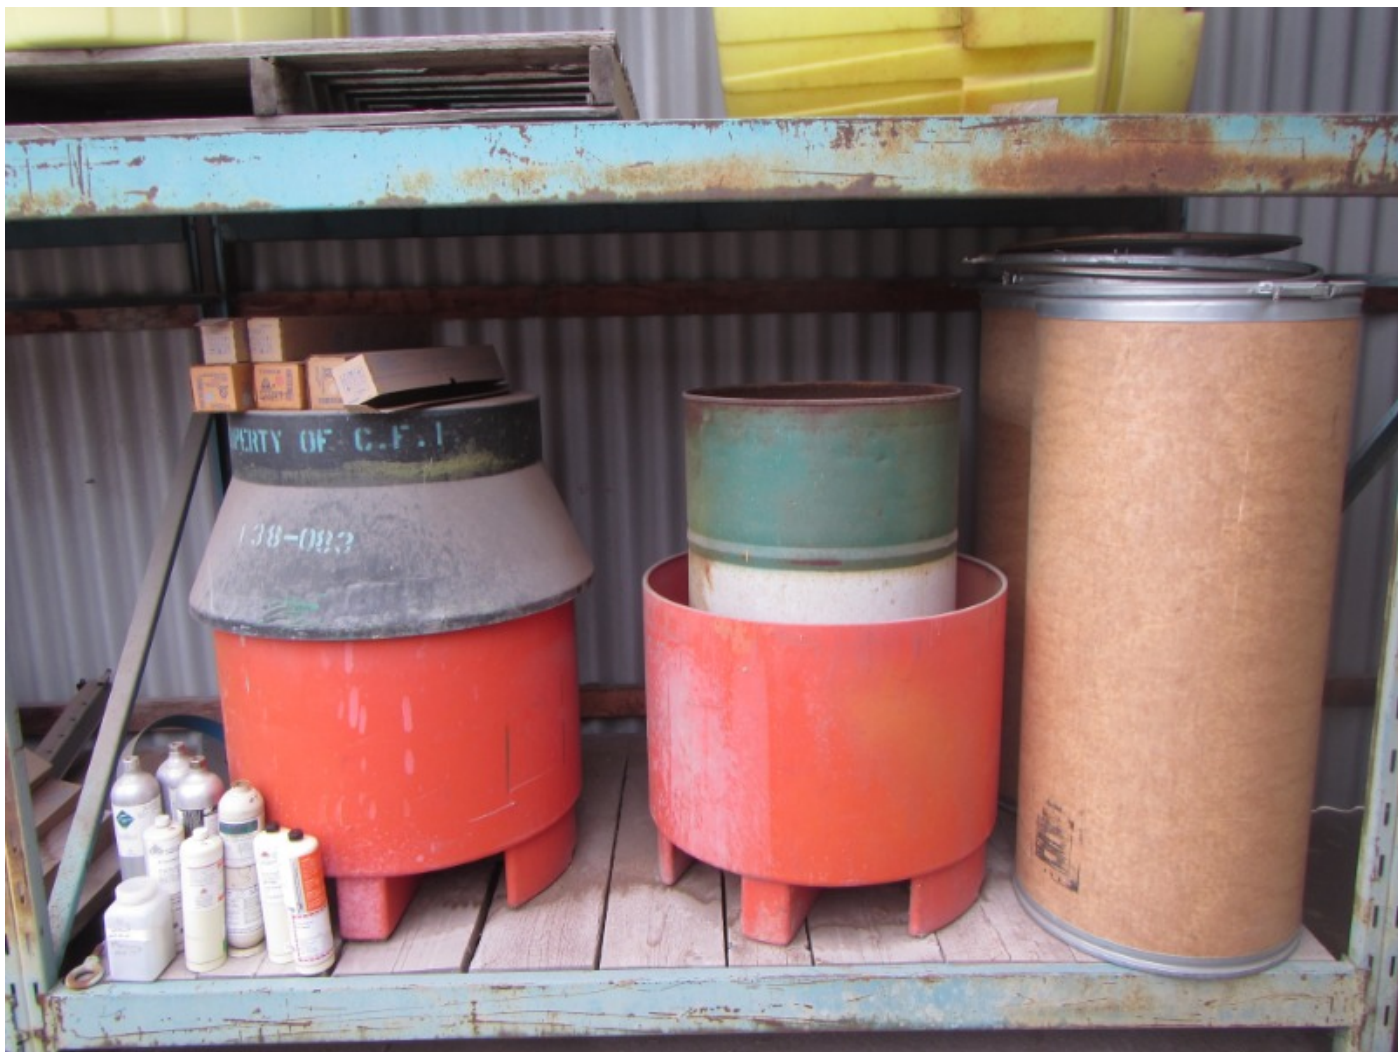
Img : IMG_2618.jpg

Details/Findings:	Some hazardous waste observed during the site inspection was not clearly labelled with the shipping name, and class and UN number where applicable (Photos 1, 2).
Compliance:	Out
Actions to be taken:	Ensure the outside of all containers used to store or transport hazardous waste is clearly labeled with the shipping name of the hazardous waste it contains. If the hazardous waste is a dangerous good, ensure the label includes the class and UN number of that hazardous waste, both as set out in the federal dangerous goods regulations.

Img comment: Photo 1. Hazardous waste container without lid. Unlabeled wastes.

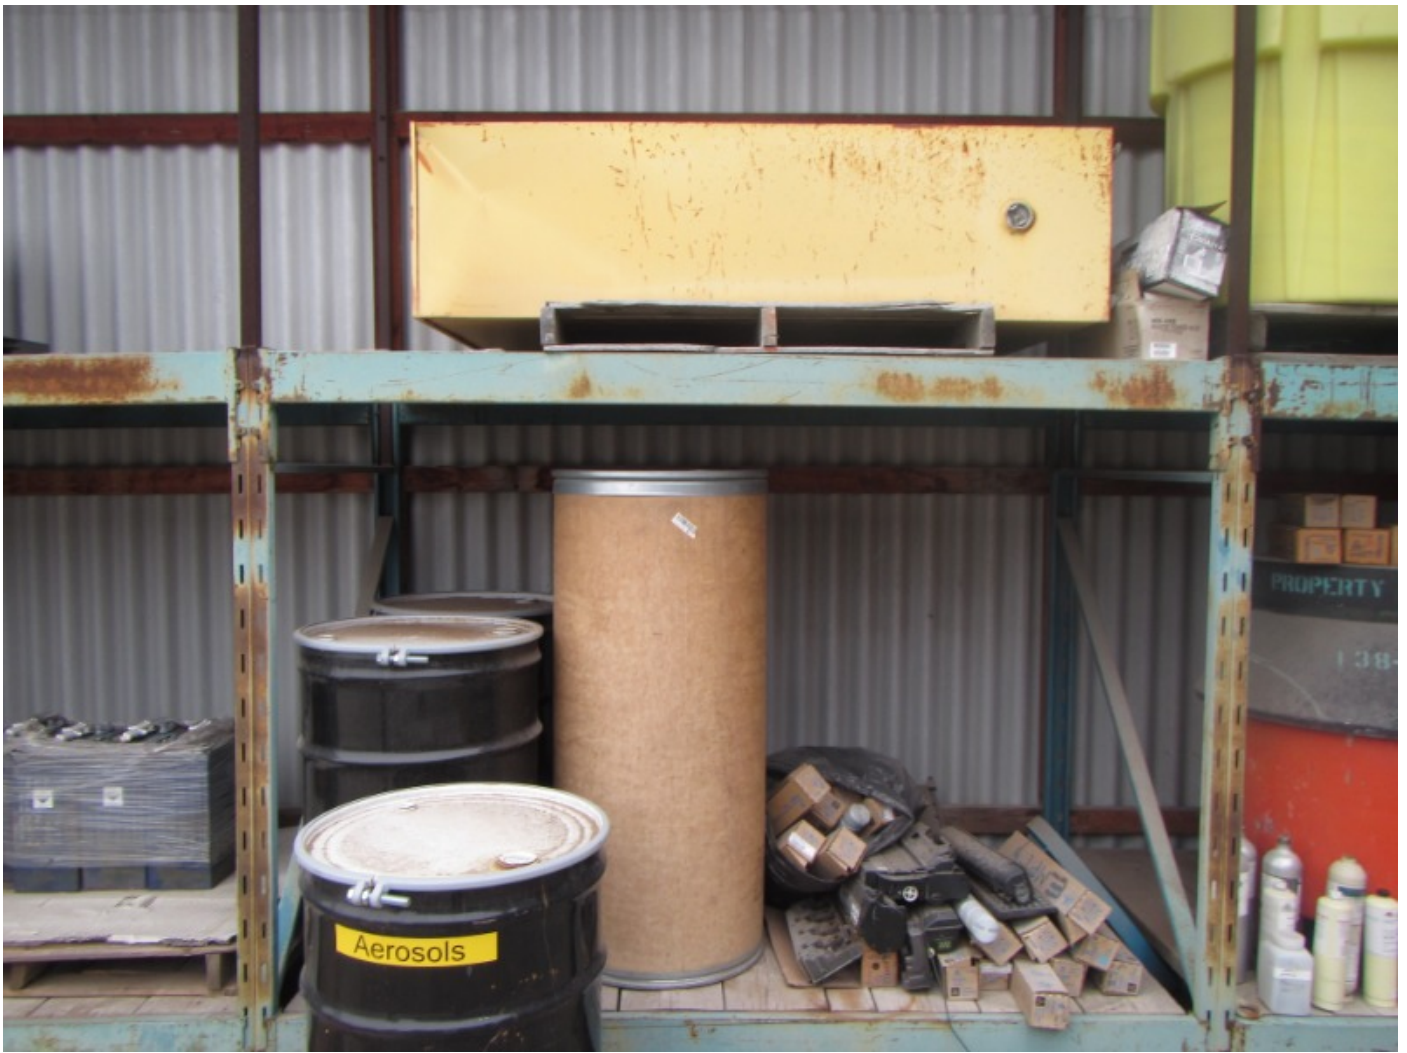
Img : IMG_2617.jpg

Img comment: Photo 2. Unlabeled containers storing hazardous waste.
